# Update to Clients

## SAI Helps Insurer and Regulators Complete a Complex & Challenging Project

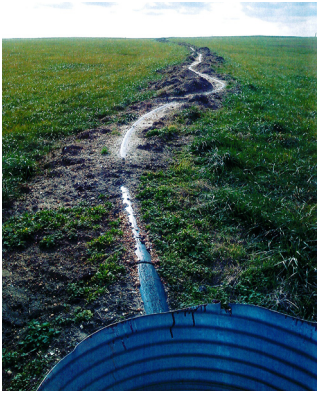
### What Not To Do

The designers of this gas line (not SAI) clearly neglected to account for thermal stressors during the design phase. This gas line, which should be straight, shows the buckling and warping that these stressors can cause.

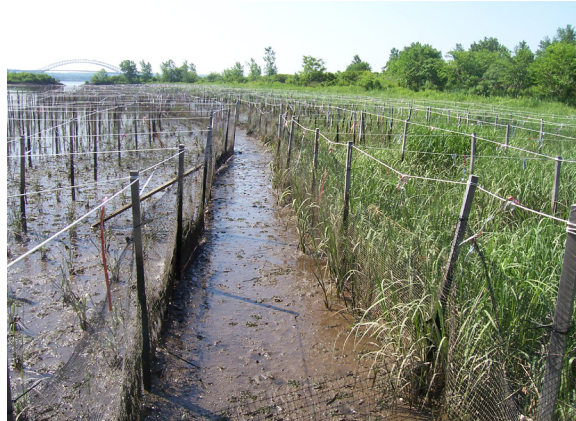
*A close-up of the goose exclosures designed and maintained by SAI to encourage growth of wetland plants in the mitigation area.*

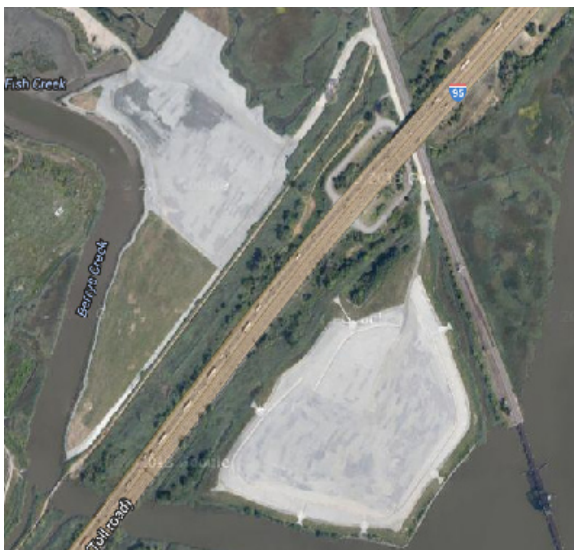
An image from Google Earth showing the landfills for Rutherford East and West.

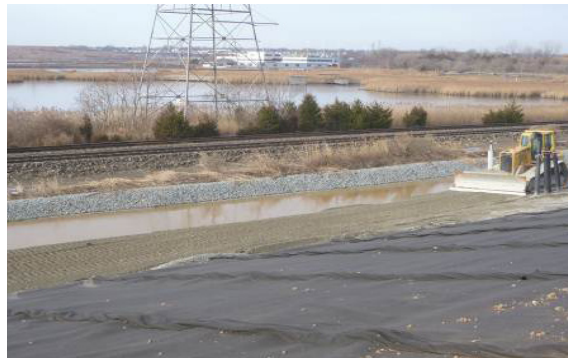
*A view of the railroad tracks adjacent to the Avon Landfill.*

The Avon Landfill is bounded on the south by NJ Transit train lines that flood frequently, and on the north by two 100-year-old water supply lines that provide water to Jersey City and are highly susceptible to additional stresses. This made the cap design particu-

larly sensitive. SAI considered several options, including different configurations of conventional caps with a covered or exposed geomembrane barrier layer. Our engineers had to consider carefully how the cap would impact the landfill's water infiltration rate, settlement, leachate levels (and the resulting effect on the structural integrity of adjacent utilities). SAI also performed global and veneer slope stability analyses, and examined the impacts of the 25-year storm. SAI settled upon capping the landfill with processed dredge material and soil cover to minimize impacts on the adjacent pipelines and flood-prone railroad.

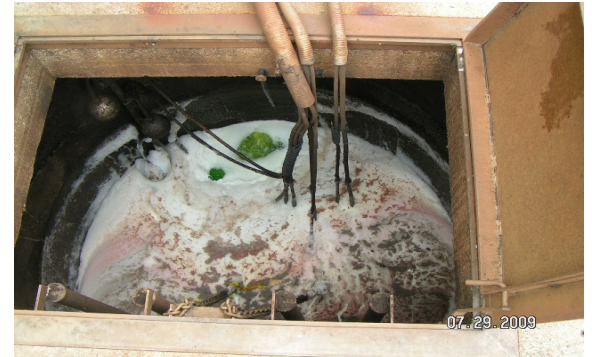
*Leachate from the Kingsland Landfill.*

The installed leachate system at the Kingsland Landfill was not performing to expectations due to a collapsed pipe. SAI discovered this issue while conducting a video inspection. SAI designed a replacement pipe for the collapsed portion of the leachate system, rendering it intact and functional once again. SAI also designed stormwater downchutes to address settlement of some installed stormwater pipelines.
