Vol. 33, No. 1

Environmental Investigation and Permitting at a Waterfront Club

Cape May Lower Township Landfill Closure Study

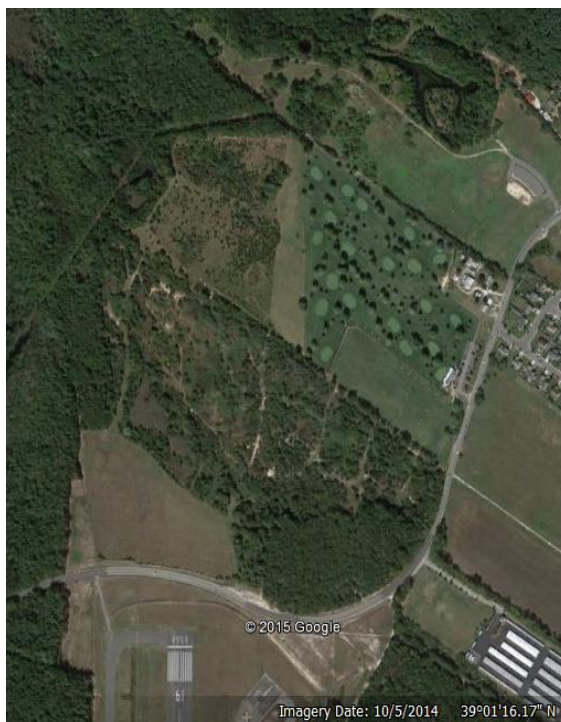
Above, an aerial photograph of the site taken from Google Earth. The adjacent golf area is clearly visible to the right, and the end of a runway can be seen at the bottom of the photo.

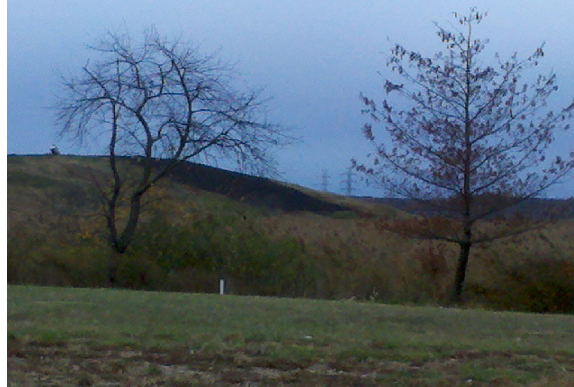
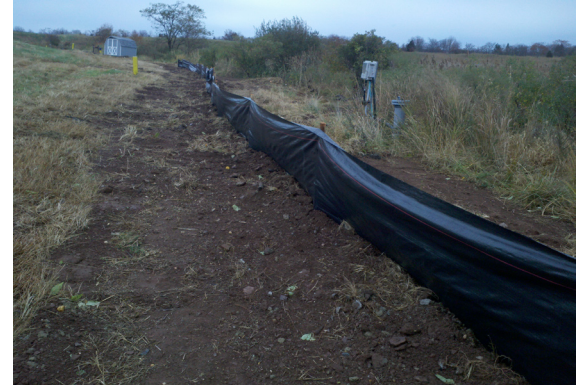
Above and top right, views of clean dredge material used for landfill cap maintenance.

be able to utilize the clean dredge material. Fortunately, one of SAI's clients, Industrial Land Reclaiming, Inc. (ILR) of Edison, NJ needed clean soil to repair depressions on the side slopes of their closed landfill. ILR accepted 37,000 cubic yards of the Tappan Zee dredged material that met the most stringent soil cleanup standards.

The material was placed and covered with six inches of topsoil to help reestablish the vegetative cover.
